DEPARTMENT OF TRANSPORTATION**DIVISION OF ENGINEERING SERVICES**

Contract #: 04-0120F4Cty: SF/ALA Rte: 80 PM: 13.2/13.9File #: 1.28**WELDING INSPECTION REPORT****Resident Engineer:** Siegenthaler, Peter**Address:** 333 Burma Road**City:** Oakland, CA 94607**Report No:** WIR-017761**Date Inspected:** 01-Nov-2010**Project Name:** SAS Superstructure**OSM Arrival Time:** 1000**Prime Contractor:** American Bridge/Fluor Enterprises, a JV**OSM Departure Time:** 1830**Contractor:** American Bridge/Fluor Enterprises, a JV**Location:** Job Site

Caltrans Office of Structural Material (OSM) Quality Assurance Inspector (QAI) Joselito Lizardo was present at the Self Anchored Suspension (SAS) job site as requested to perform observations on the welding of components for the San Francisco Oakland Bay Bridge (SFOBB) Project.

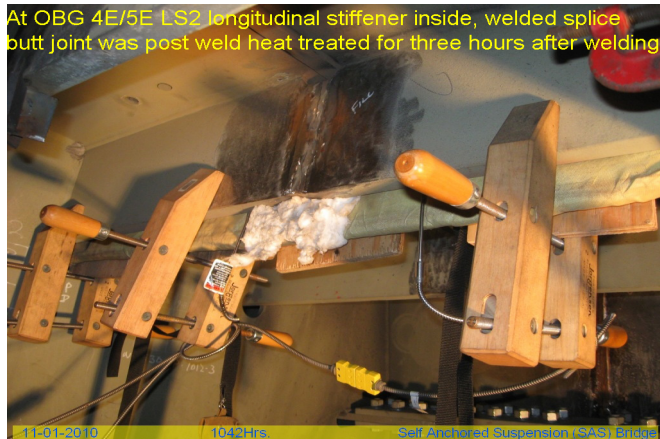
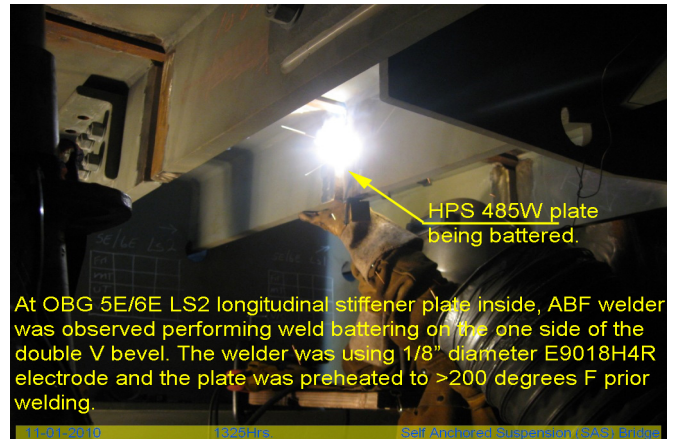
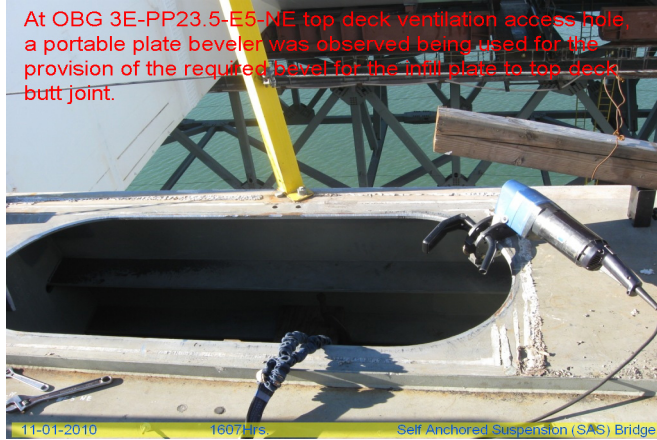
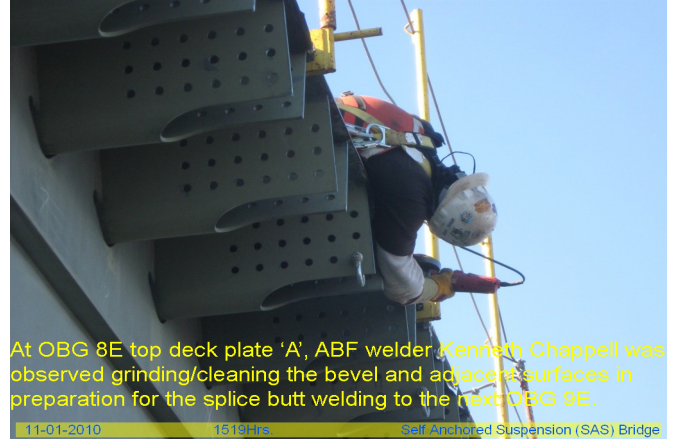
At OBG 5E/6E LS5 longitudinal stiffener inside, QA randomly observed ABF welder Xiao Jian Wan ID #9677 perform 3G (vertical) Shielded Metal Arc Welding (SMAW) complete joint penetration (CJP) welding fill pass on the stiffener splice butt joint. The stiffener plates being welded are made of high strength plate material HPS 485W and has a thickness of 30mm. The joint has a double V joint preparation that was welded from one side and after the completion from one side, to be back gouged; Non Destructive Testing (NDT) tested using Magnetic Particle Testing (MT) and back welded to the other side. Prior welding, the fit up was inspected and accepted by ABF QC John Pagliaro. QA also verified the root gap of less than 8mm and alignment of less than 2mm which deemed acceptable to the contract requirements. The welder was noted using E9018H4R with 1/8" diameter electrode implementing Caltrans approved welding procedure specification (WPS) ABF-WPS-D1.5-1012-3. The joint being welded was root welded using a ceramic backing. The splice joint was preheated and maintained to greater than 200 degrees Fahrenheit using Miller Proheat 35 Induction Heating System heater blanket located at the opposite side of the plate prior/during welding. The QA Inspector noted the ABF QC John Pagliaro was on site monitoring the in process preheats and welding parameters. During the shift, QA noted ABF QC was closely monitoring the issuance of E9018H4R electrodes due to its limited exposure time allowed. At the end of the shift, fill pass welding was still continuing and should remain tomorrow.

#2930 perform vertical battering using Shielded Metal Arc Welding (SMAW) on the longitudinal stiffener LS2 splice butt joint. The joint has a double V joint preparation that has a 15mm root gap. The welder was using E9018H4R with 1/8" diameter electrode implementing Caltrans approved welding procedure specification (WPS) ABF-WPS-D1.5-1012-3. The splice joint plate was preheated and to greater than 200 degrees Fahrenheit using propane gas torch prior welding/battering. During the shift, the welder has completed battering the LS2 and has moved to LS1 and put in place the Miller Proheat 35 Induction Heating System heater blanket in preparation for the 3G (vertical) splice butt welding. The QA Inspector noted the ABF QC Inspector John Pagliero was on site monitoring the in process preheats and welding parameters. During the shift, QA noted ABF QC was closely monitoring the issuance of E9018 electrodes due to its limited exposure time allowed.

At OBG 7E/8E side plate 'E' (7855mm to 9955mm) inside, QA randomly observed ABF/JV qualified welder Sungtao, Huang ID # 3794 continuing to perform CJP groove welding fill pass on the splice butt joint. The welder was observed perform automatic welding in the 3G (vertical) position utilizing a dual shield Flux Cored Arc Welding (FCAW-G) with E71T-1M, 1/16" diameter wire electrode and implementing Caltrans approved Welding Procedure Specification (WPS) ABF-WPS-D15-3042A-1. The joint being welded has a single V-groove butt joint with backing bar. The splice joint was preheated and maintained to greater than 150 degrees Fahrenheit using Miller Proheat 35 Induction Heating System heater blankets located at the opposite side of the plate prior/during welding. During welding, ABF Quality Control (QC) William Sherwood was noted monitoring the welding parameters of the welder. At the end of the shift, fill pass welding on the splice butt joint was still continuing and should remain tomorrow.

Other activities observed during the shift include grinding of the bevel and adjacent weld metal on the OBG 8W top deck plate and beveling of ventilation access hole top deck edge and its infill plate at OBG 3E-PP2.5-E5-NE. Mike Maday who was doing the beveling was using a portable mechanical beveler as shown on photograph.
